DIAGNOSTIC CATALOG

HAMMER
Kupplungen

1. TROUBLESHOOTING CLUTCH SYSTEM MALFUNCTION

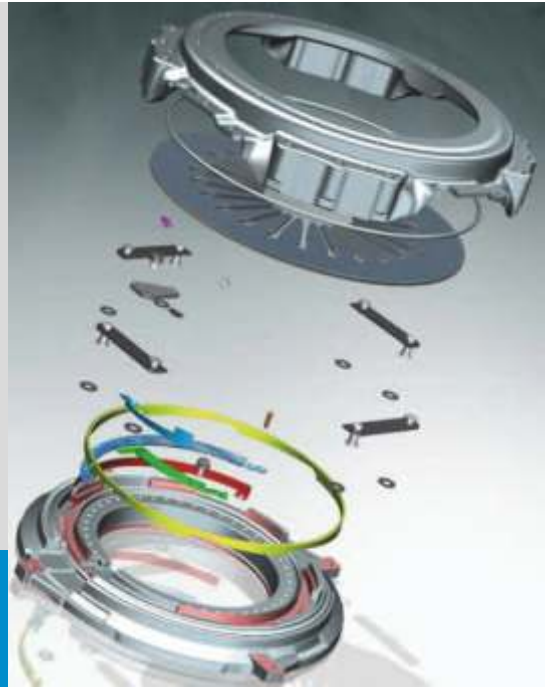
Self-adjusting (x-tend) clutch sets produced for Mercedes Travego and Actros (Euro 6) vehicles provide a longer lifetime in comparison to normal clutches and ensure consistent clutch pedal force through the lifetime, providing ease of use. As seen in the image these products work synchronized with the adjustment mechanism and therefore the whole set must be changed in case of replacement.

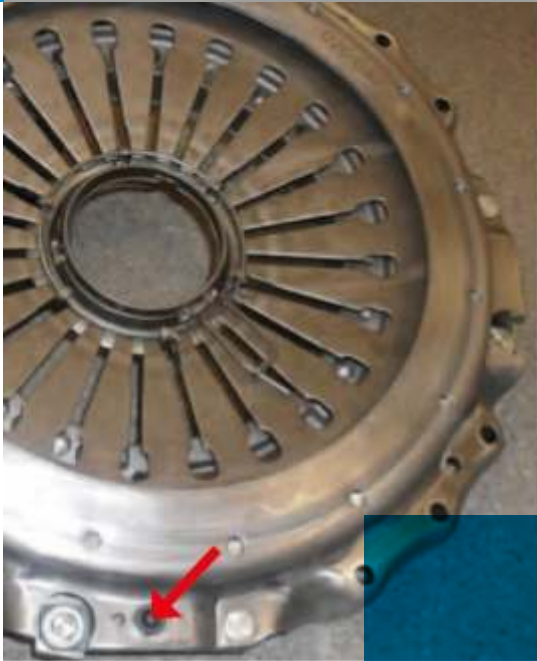
In case the clutch must be removed from the vehicle for any reason, the bolt indicated with the arrow should be loosened 2 tours before untightening bolts, and after the clutch is tightened in place this bolt should be re-tightened with 35-43 Nm torque. Do not completely unscrew the stop bolt!

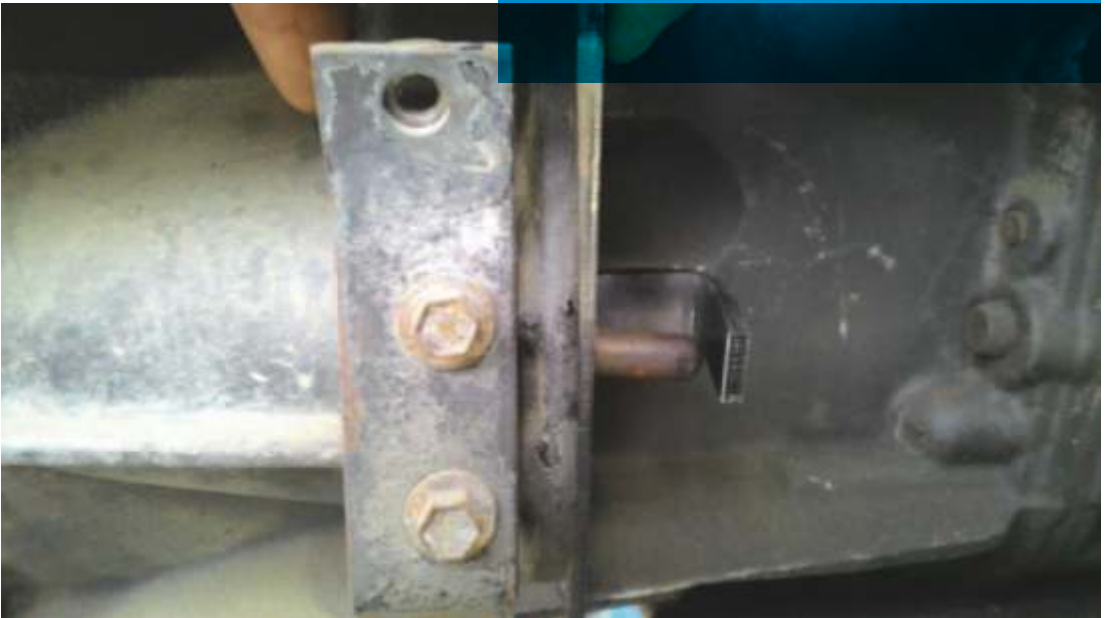
Today the number of semi-automatic vehicles are in demand. Heavy commercial group also uses this type of vehicles. Especially in Axor and Actros vehicles in Mercedes group the clutch fork distance should be adjusted to 37 mm using the adjustment apparatus below after any clutch replacement. Clutch judder or clutch fail to disengage problems may occur if this adjustment have done inappropriately

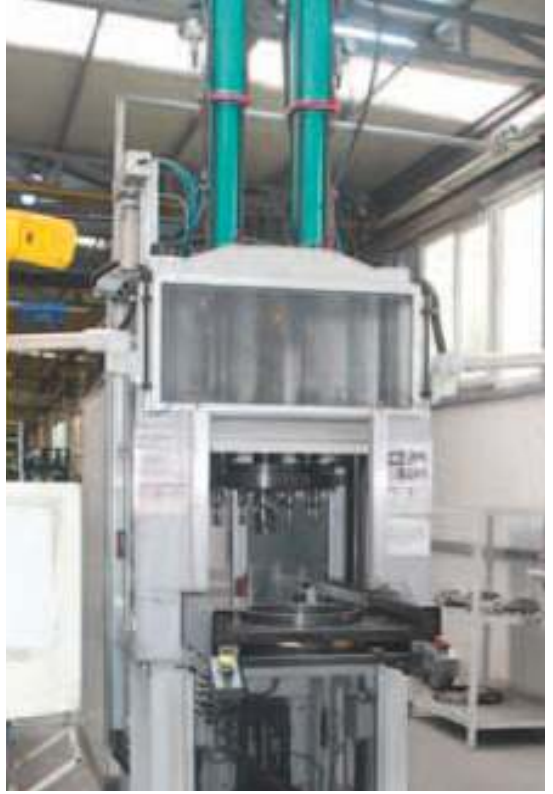
The clutch fails to disengage if the parameter showing the clutch release value (column pressure plate lift) on the measurement table becomes decreased due to reasons detailed below.

(The image on the clutch test device is only for demonstration purposes.)

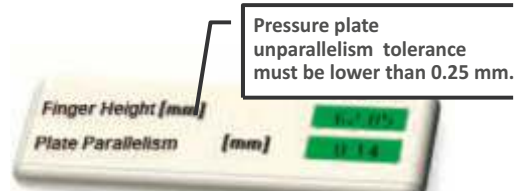
2.3 High unparallelism on pressure plate

The clutch plate should move perpendicularly from friction surface during all releasing cycles

This important technical aspect is checked 100% with the test devices in our company before delivery.

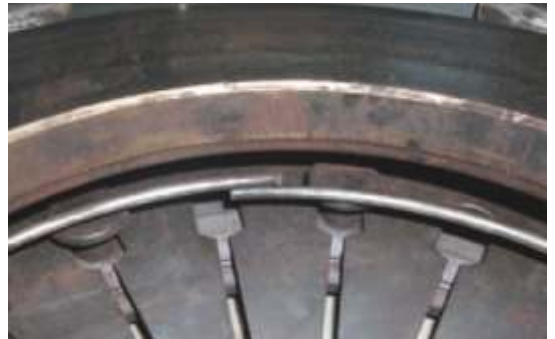
2.4 Fulcrum Ring is Broken

1 or 2 pieces of fulcrum ring is used according to clutch type to allow movement of the clutch diaphragm spring.

For the clutch to be able to release this ring must not be broken or worn.

A broken fulcrum ring can be seen in the image.

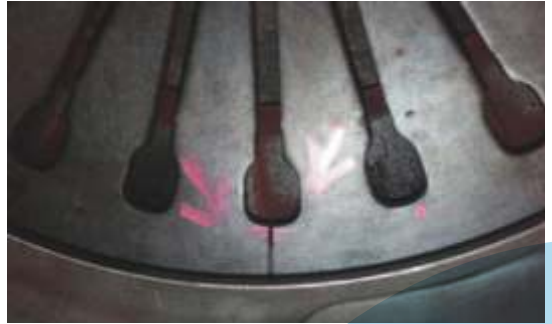
2.5 Clutch diaphragm spring is broken;

In case the clutch diaphragm spring is broken as the image the clutch fails to disengage . Typically produced from high quality steel, this part does not break based on design and production reasons.

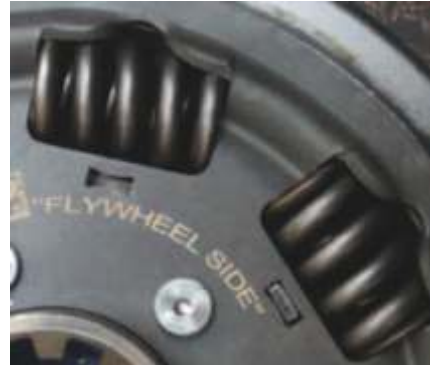
2.11 Clutch Disc is not mounted in right direction

In case of mounting the disc in wrong direction, this will cause to fails to disengage

- Not appropriate product has been selected for the vehicle,
- Demounting the products from the vehicle without paying attention to their position,
- Not paying attention to the warnings in the Dönmez catalogue,
- Not paying attention to the directions or warnings on the clutch disc. (as seen in the image)

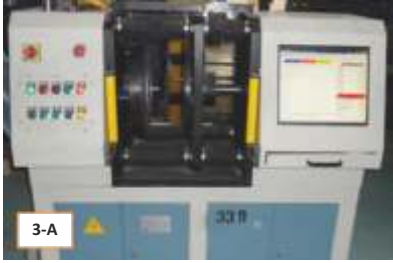
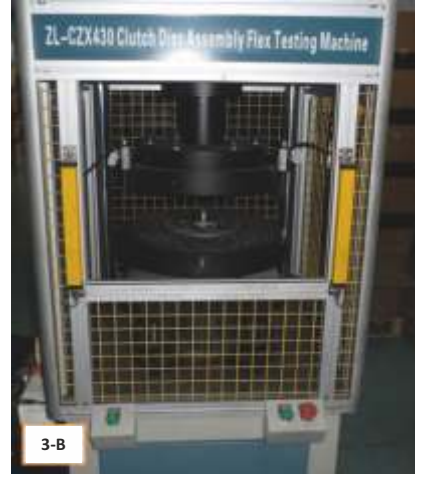
- The freemovement (seen in 3-A image free rotational motion without runout) should be maximum 1 mm.
- The disc assembly flexibility (seen in 3-B image disc flexure device) is measured with our test device.

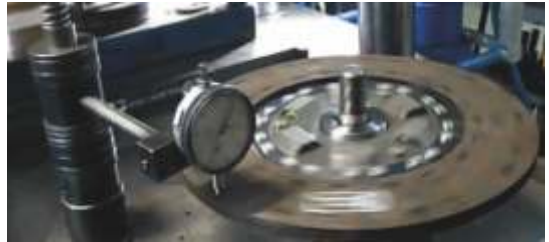
3.7 Flatness of the clutch disc is inappropriate

The friction surfaces of the clutch disc (friction facings) should achieve the flatness under every condition. Our products are sent to our customers after they are 100% controlled.

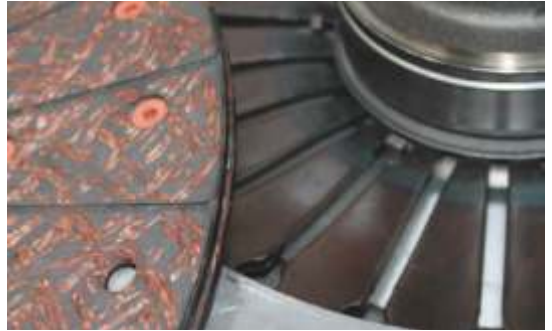
3.9 Lubrication and/or burn of the clutch disc

The excessive heat at the clutch system will damage the friction material (friction facing) used on the disc. Excessive heat should not be formed in the system. Likewise, the friction facing surfaces should be dry and not contaminated with grease or any other oil. Before the clutch disc is mounted in its place, transmission input shaft splines should not be excessively lubricated.

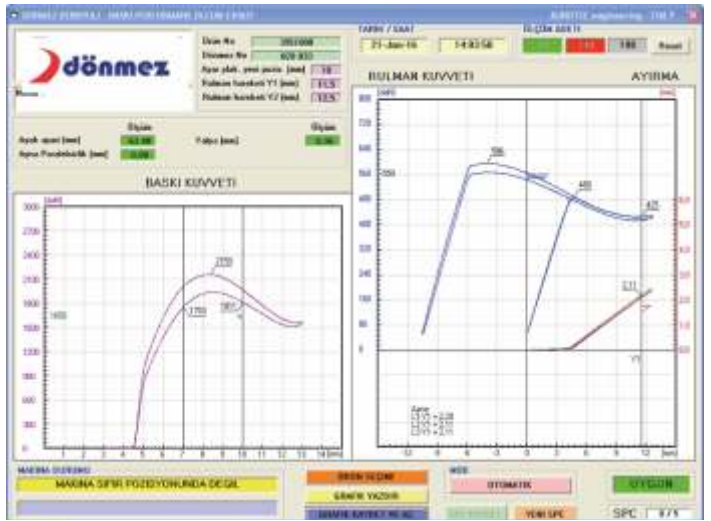
Duty of the clutch is to transmit the rotary motion from the engine to the transmission box without any loss. It is called as slipping that there is not an increase at the vehicle acceleration although engine speed has been increase when there are losses. In order to that there is no slipping complaint in our products, our clutch cover assemblies and discs are subjected to 100% control with measurement devices in our company. Especially the compression force (clamp load) of the clutch cover assembly for compressing the clutch disc to the flywheel is the most important factor slipping complaint. Therefore, we take this force under warranty with below performance test.

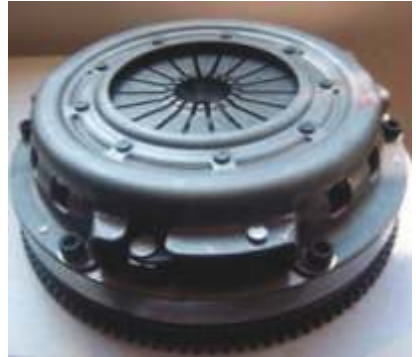
4.2 Clutch is not mounted properly on flywheel

Along with that clutch cover assemblies vary according to the designs, some clutch cover assemblies are centered to the flywheel from outer diameter and some of them are centered with pin. Therefore, it should be controlled that they should be installed on the flywheel from centering and/or reference points at right position.

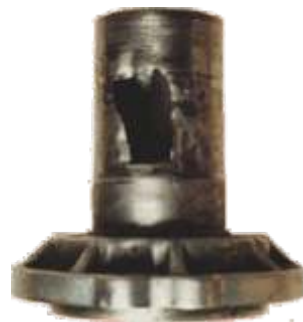
It is the part that makes guidance to motion of clutch release bearing. It should be on the same axis with the transmission input shaft definitely. Bent, worn transmission input shaft covers prevent reverse travel of the release bearing on the cover. Therefore, clutch operates in a partially disengaged condition. Slipping problem may occur.

Causes;

- a. Operation of the clutch release bearing on the
- b. transmission input shaft cover with inappropriate grease,
The clutch release bearing has not been greased at appropriate amount and/or has not been greased,
- c. Using clutch release bearing that has completed its lifetime,
- d. The axial misalignments of the engine and transmission.

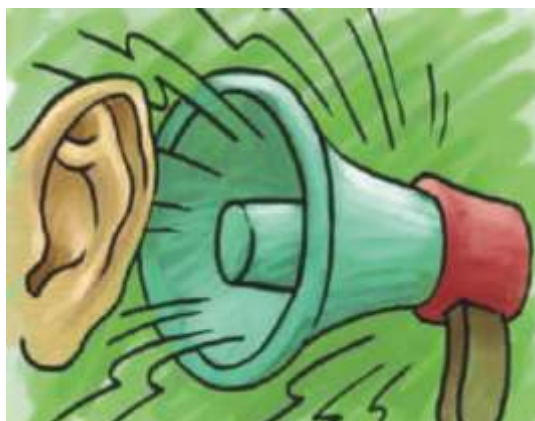
5. CLUTCH MAKES A NOISE (RATTLING)

In general, the clutch makes a noise during its operation. This is resulted from internal dynamics of clutch cover, disc and bearing assemblies. Especially quality of clutch bearing balls is one of the main causes of noise formation.

The noise levels of the clutch bearings that we produce as Donmez Clutch are taken under control as 90 db.

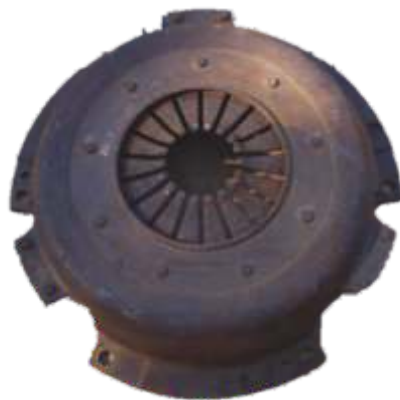
- Installing inappropriate clutch cover assembly to the vehicle,
- Usage of excessively rusted products,
- The foreign matters that have entered between clutch cover assembly release fingers,
- The clutch cover assembly release fingers are excessively worn,
- The clutch cover assembly release fingers are not parallel,
- Excessive unparallelism of pressure plate on disengagement situation,
- The clutch cover assembly is misaligned from centering bore and/or centering pins

The listed items above will cause to vibratory operation of clutch pedal.

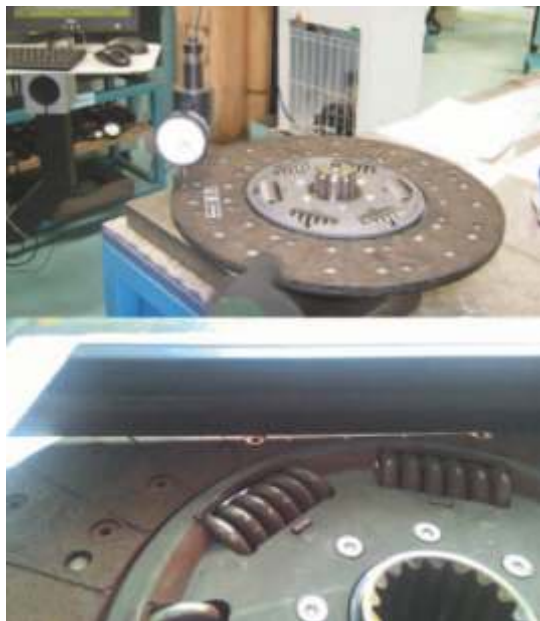
5.3 Flatness of the clutch disc is not appropriate

The friction surfaces of the clutch disc (friction facings) should achieve the flatness under every condition and its free movement without runout should be under 1 mm. Our products are sent to our customers after they are 100% controlled.

- Due to transportation conditions clutch sets and/or discs have become inappropriate (bent or damaged..),
- During installation of the clutch system to the vehicle, transmission weight has been carried by the disc spline,
- Revised products have been used.

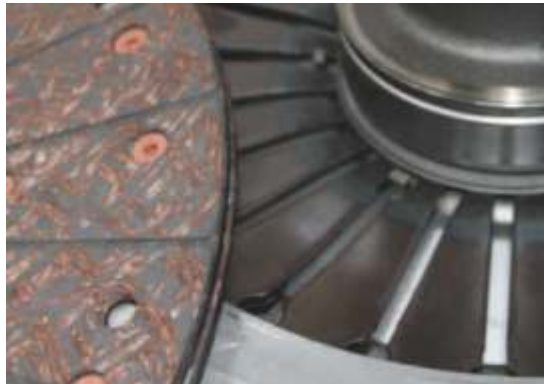
5.4 Clutch friction facing quality is not appropriate

The clutch disc lifetime, comfort and performance is directly proportional to the friction facing quality. The friction facing quality should be selected in accordance with vehicle type, road conditions, vehicle equipments and job. Please request the product corresponding to your vehicle in Donmez Clutch catalogue.

- a. Using inappropriate clutch disc for the vehicle
- b. Especially for the bus group vehicles, comfort purpose high quality friction facings are in our catalogue.

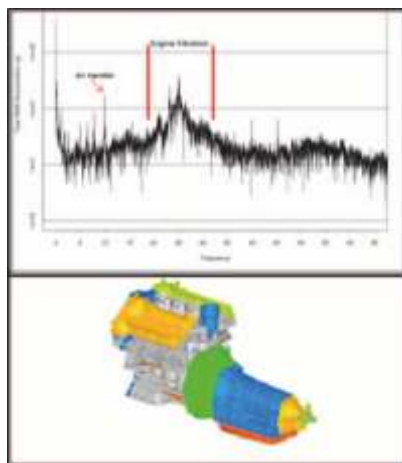
5.8 Vibratory operation of the system in general

If the vibratory operation resulted from engine and powertrains still continues after the new clutch replacement, this situation may be called as judder. The complaint of noise may be experienced due to that complaint of judder continues.

- The vibrations resulted from the fuel system on the engine,
- Replacement life of the engine has been completed and/or about to be completed,
- Inappropriate modifications on the technical data of the vehicle,
- Vehicle usage errors.

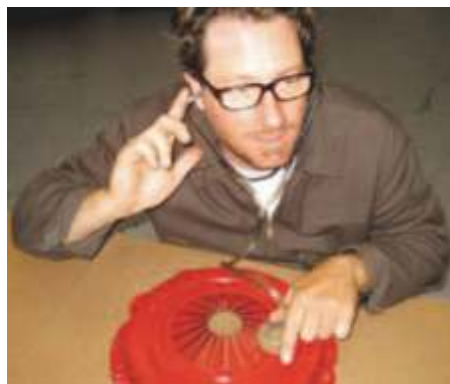
5.9 Misuse of Drivers

Lifetime and performance of Donmez Clutch products that you prefer may be adversely effected from using habits. After this situation continues for a specific period, complaint of slipping will occur in the vehicle. When the slipping complaint continues, complaint of high sound will occur.

- Not paying attention to the clutch releasing or operating point,
- Using vehicle at incorrect gear levels and incorrect engine speed rates.

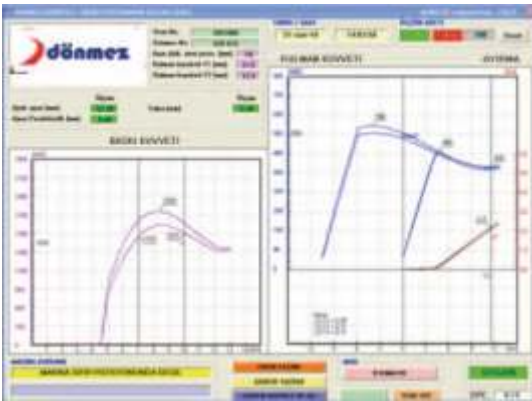
The clutch pedal of the vehicles is operated by the users' applying approximately 12-13 kg force. If the pedal is needed to be pressed with a force above than this value, the complaint of hardness will occur.

All these are defined as comfort deficiency at the clutch. This performance parameter has been taken under control with test tools in our company.

The image at the right side, test device output showing accuracy of this property is seen. It is known that majority of the uncomfortable operation of the clutch pedal is resulted from the abnormalities on the clutch cover assembly. Therefore, every product is 100% controlled before delivered to you.

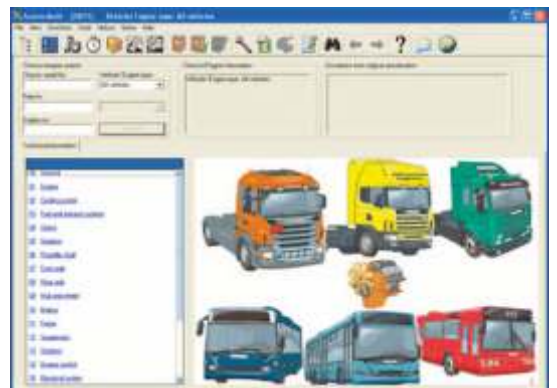
6.1 Using inappropriate clutch cover assembly and/or disc for the vehicle

Using inappropriate products for your vehicle will adversely effect the pedal comfort. Therefore, you should make appropriate clutch selection according to your vehicle.

- Product selection should be done according to vehicle type and chassis.
- Accuracy of Donmez Clutch products should be checked from the vehicle chassis number.
- Not using same brand products (Cover assembly, Disc and Bearing) in general.

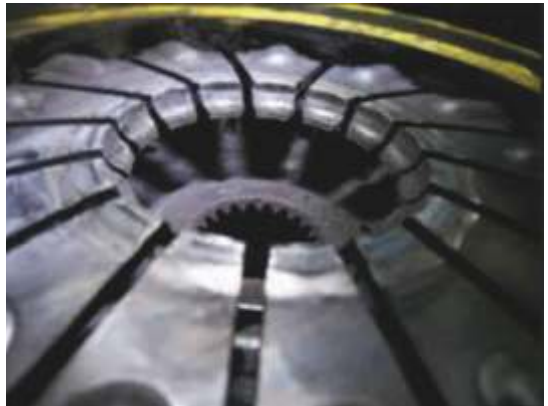
6.2 Diaphragm spring fingertips are worn

Another cause of uncomfortable pedal operation is that contact point of the clutch bearing and cover assembly has been worn. It will cause uncomfortable operation if the wearing is excessive.

- Using inappropriate product on the vehicle,
- Finger height is not appropriate,
- Bearing pedal gaps are out of tolerances, Compulsions at rotary motions of clutch bearing (cracked or damaged),
- Vehicle usage errors.

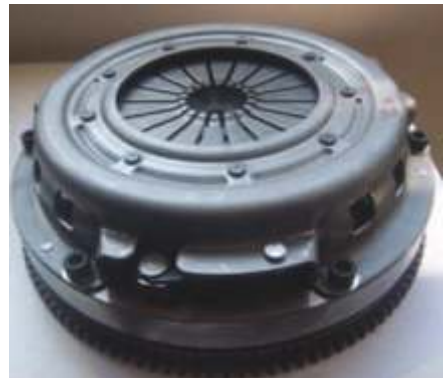
6.3 Clutch is not mounted properly on flywheel

Some cover assemblies are centered to the flywheel from the outer diameter and some others are centered to the flywheel with a pin. Therefore while cover assemblies are installing to the flywheel, centering and/or whether it is inserted at the right position from reference points to the flywheel should be checked.

- While tightening the clutch cover assembly to the flywheel, all bolts are to be tightened in sequential order and with equal torque values,
- At the surfaces that cover assembly is placed at the flywheel, there should not be residuals that will prevent equal tightening,
- The depth that disc and cover assembly are placed at pot type flywheel should be in conformity with the values in the catalogue.

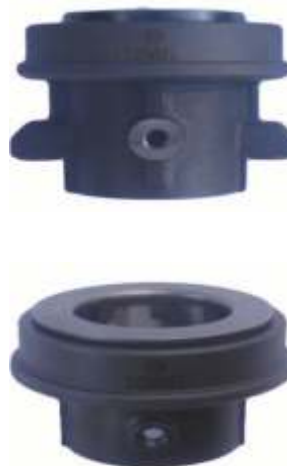
6.4 Clutch release bearing type is not appropriate

Another cause of uncomfortable operation is that using the bearing assembly not according to the cover assembly. If the diaphragm spring's fingertip is flat, release bearing's surface should be ribbed and if the diaphragm spring's fingertip is radius, the surface of release bearing should be flat.

- Release bearing assembly is not selected according to clutch cover assembly,
- Inappropriate repairs or modifications

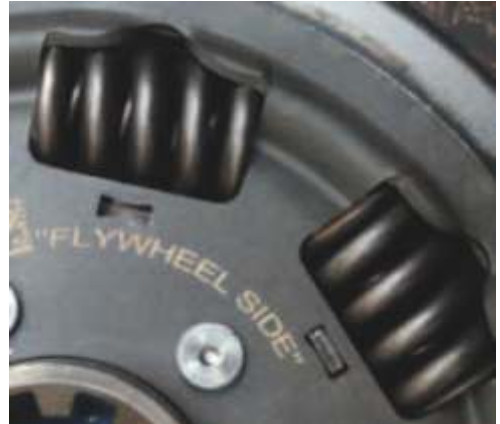
6.6 Clutch disc has not been installed on the vehicle accurately

The clutch disc should be installed on the vehicle in the right way and/or in dual clutches, it should be installed on the right side. It will cause pedal comfort deficiency if position of clutch disc is not accurate. In general, ribbed part of the disc face towards into the cover assembly. But this situation has lost its validity for the new model vehicles. Therefore, the installation should be carried out by reviewing the directions on the disc or information in their catalogues.
